# Defect Detection and Trimming in Wire Rod Mills Driven by Robotics and Computer Vision Technology

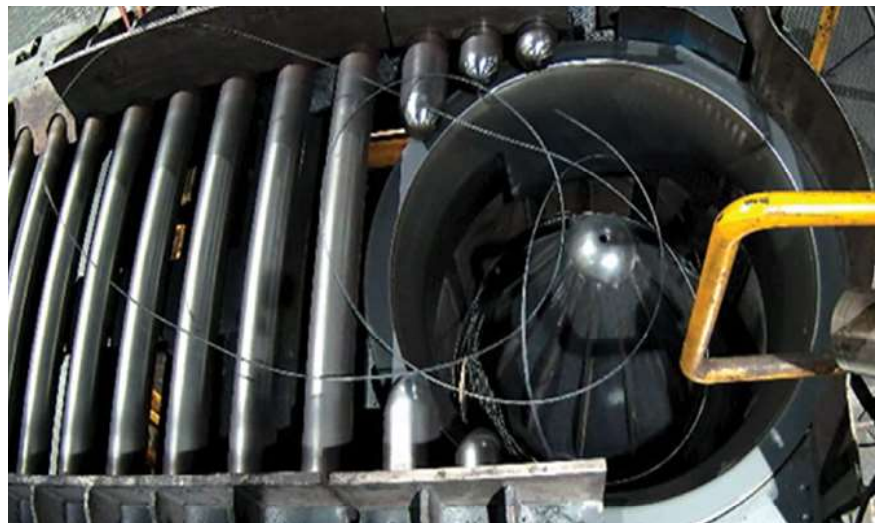
Figure 1

Cobble example in the pit during the stacking phase of the final coil.

During the production of wire rod coils, there is a possibility that the terminal part of the wire rod may exhibit anomalous configurations. In severe cases, these configurations can disrupt the correct formation of the coil in the stacking pit. To prevent such situations, operators inspect the condition of the last wire rod loops on the cooling conveyor and take the necessary actions, such as their removal (trimming) or arrangement, to ensure the proper formation of the final coil.
